The Consequences

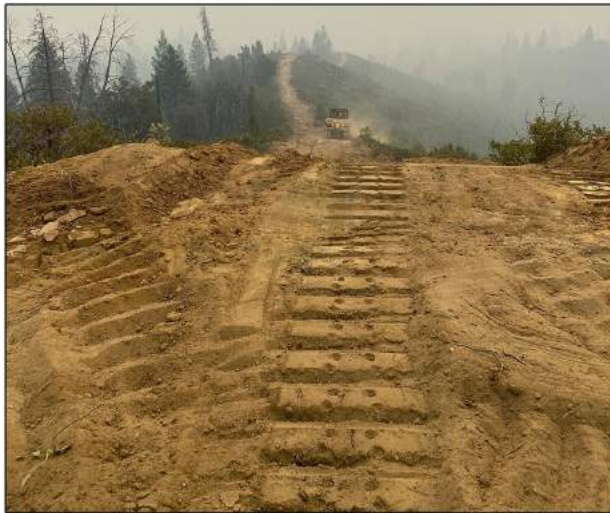
1(a)i Fireline bulldozed through proposed Pattison Wilderness during Monument Fire, California 2021.
Photo credit: Kent Collard

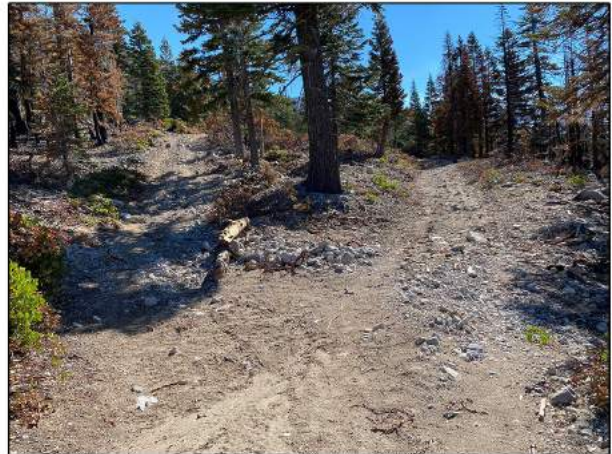
1(a)ii Diller Canyon dozerline through Mt. Shasta Wilderness during Lava Fire, California 2021.
Photo credit Luke Ruediger, Klamath Forest Alliance

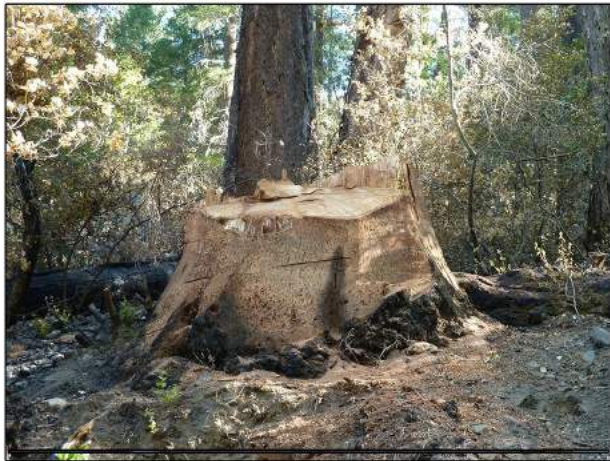
1(a)iii Large stump on dozerline Kangaroo Inventoried Roadless Area, Fort Complex Fire, Oregon 2012.
Photo credit Luke Ruediger, Klamath Forest Alliance

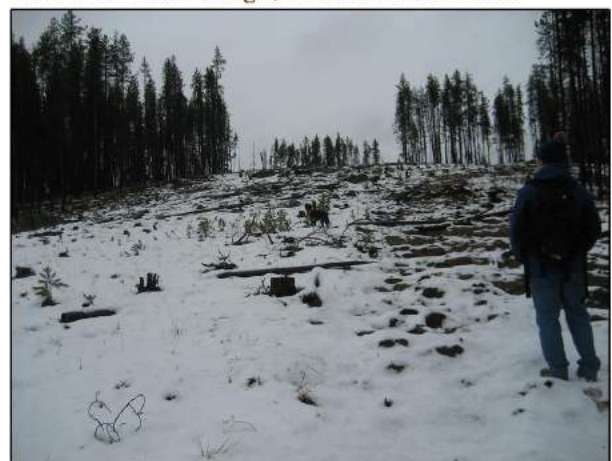
1(a)iv Fireline through Cove Roadless Area, Blue Fire, Idaho 2014. Fire was moving in the opposite direction. Fire managers discussed how to build fireline to accommodate logging trucks. Photo taken 2017.
Photo credit: Friends of the Clearwater

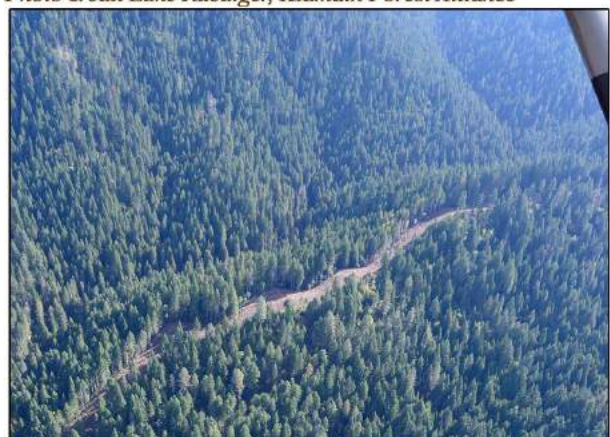
1(a)v Fireline through the Rackliff-Gedney Inventoried Roadless Area, Idaho (2017). The fire moved in the opposite direction and weeks later, Forest Service used this as a road for a logging project.
Photo credit: Alpha 1 Photography

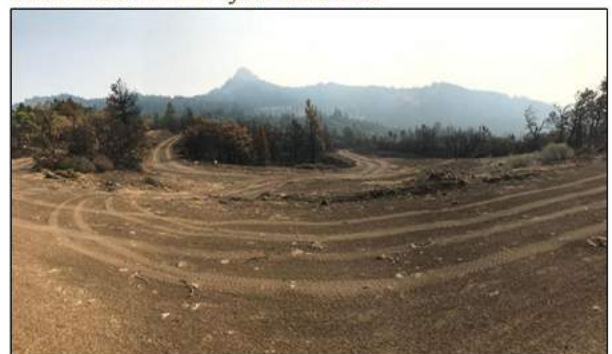
1(a)vi Junction of two firelines in Soda Mountain Wilderness. Klamathon Fire, Oregon 2018.
Photo credit: Luke Ruediger/Klamath Forest Alliance

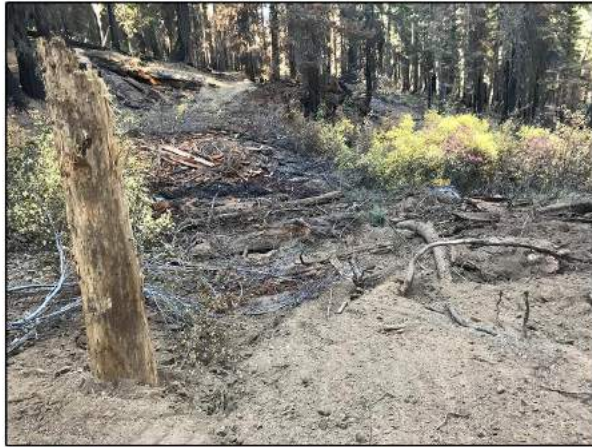
1(b)i Fireline through riparian area in the Siskiyou Wilderness, Natchez Fire, California 2018.

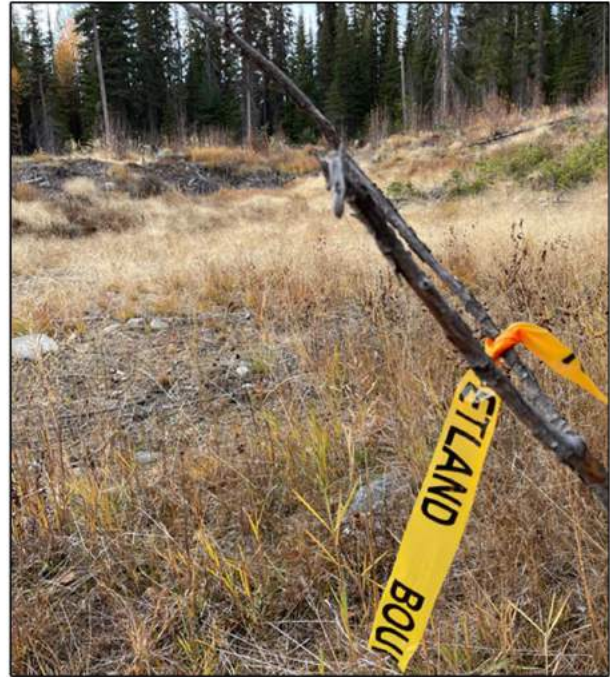
1(b)ii Fireline bulldozed through wetland area, Davis Fire, Montana 2018.

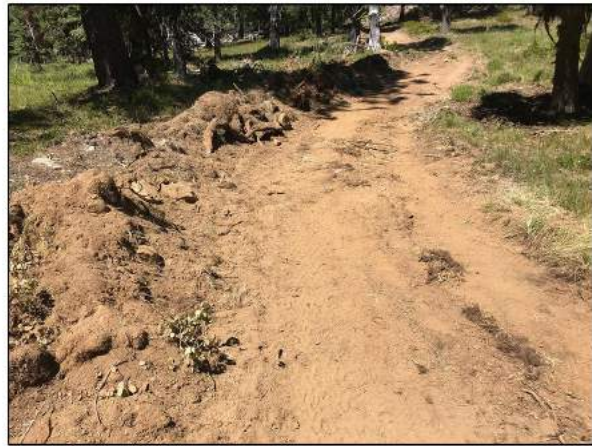
1(b)iii Fireline through Big Red Mountain Botanical Area, Hendrix Fire, Oregon 2018.

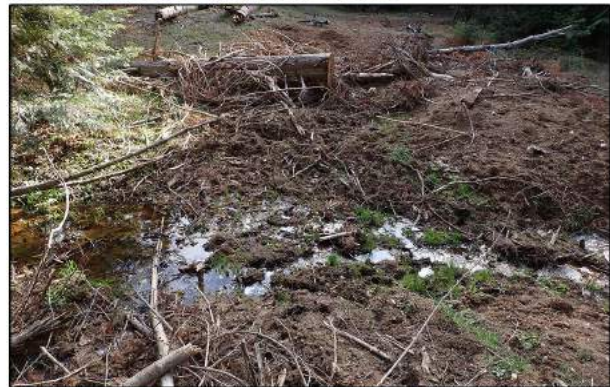
1(b)iv Dozerline crossing a half mile above where Lynx Creek becomes a perennial, fishbearing stream, Snow Creek Fire, Idaho 2021.

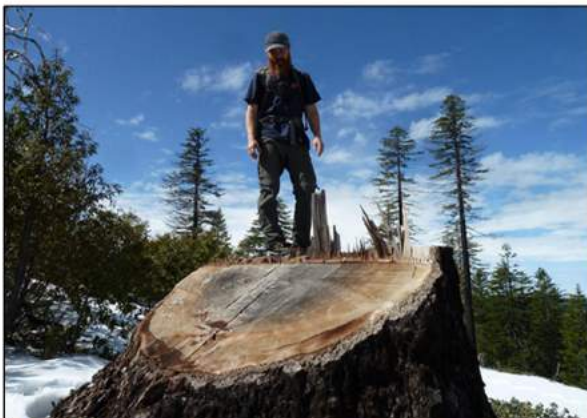
1(b)v Old-growth tree felled along a fireline in the South Kalmiopsis Roadless Area, Buckskin Fire, Oregon 2016.

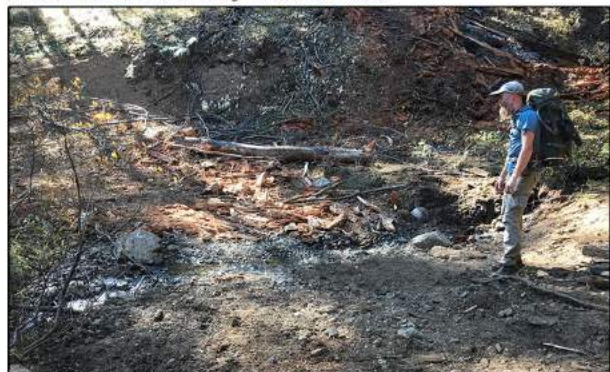
1(b)vi Fireline through headwater stream in the Siskiyou Wilderness, Natchez Fire, California 2018.

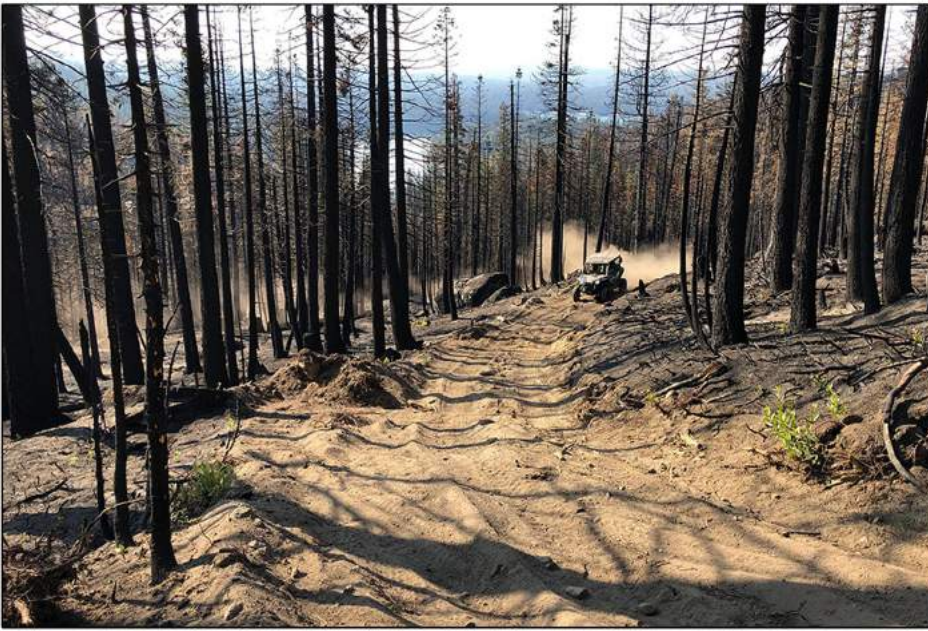
1(c)i OHV drives along fireline in Bucks Lake Wilderness during Dixie Fire, California 2021.

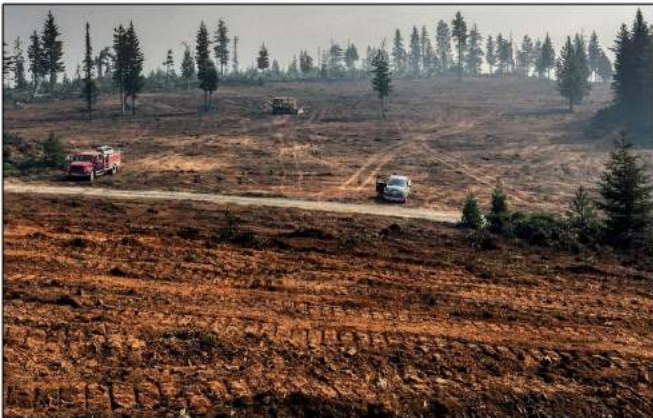
1(c)ii A massive safety zone developed above the Illinois River near the Kalmiopsis Wilderness, Klondike-Taylor Fire, Oregon 2018. *Photo credit: Inciweb*

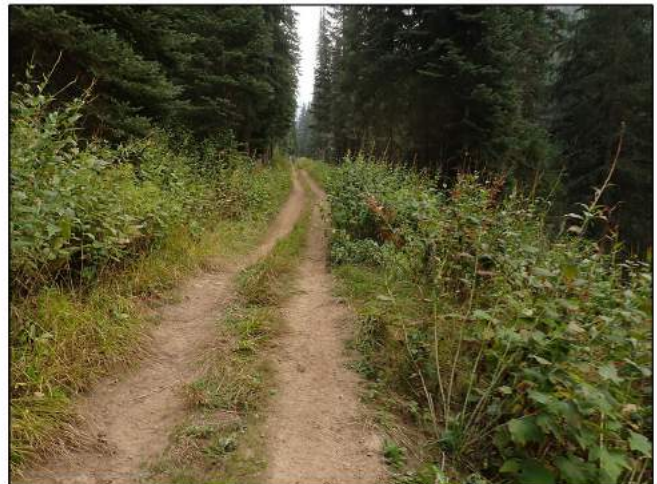
1(c)iii Dozerline widened a former pack trail over three decades ago, which became a de facto ATV access to a Recommended Wilderness.

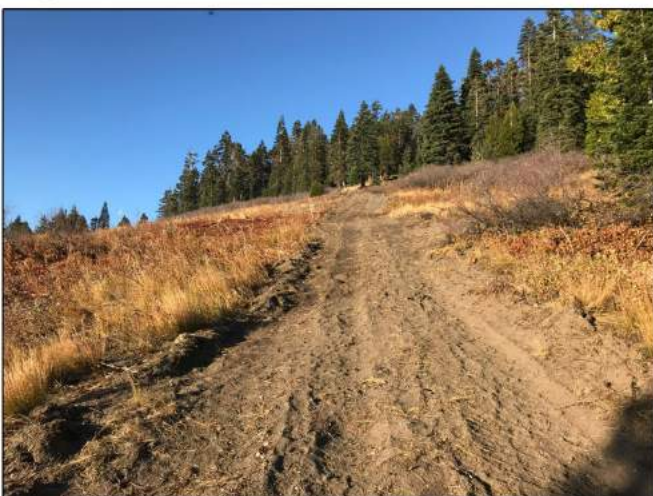
1(c)iv Fireline in high mountain meadow in Condrey Mountain Inventoried Roadless Area, Abney Fire, California 2017. *Photo credit: Luke Ruediger/Klamath Forest Alliance*

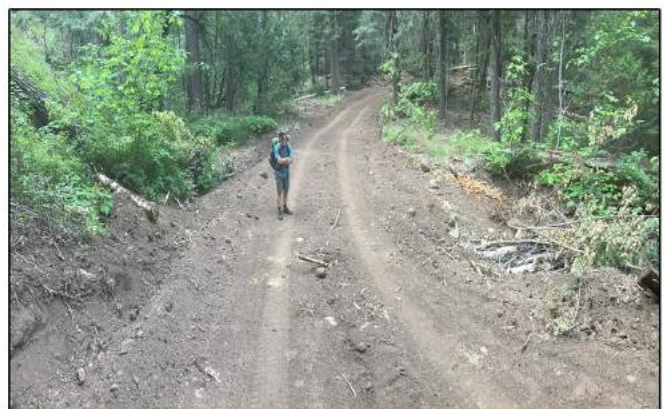
1(c)v Dozerline crossing Scotch Creek in Soda Mountain Wilderness, Klamathon Fire 2018.

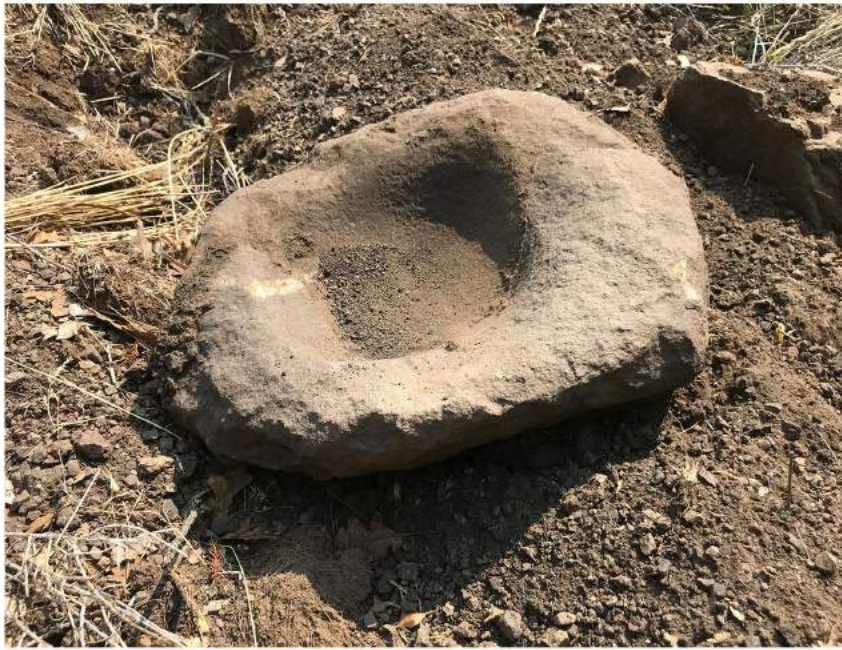
1(d)i Fireline was bulldozed through numerous archeological sites in the Cascade-Siskiyou National Monument uncovering this ancient mortar for grinding acorns, food or medicine items by Native American tribes. Soda Mountain Wilderness Klamathon Fire, Oregon 2018.
Photo credit: Luke Ruediger/ Klamath Forest Alliance

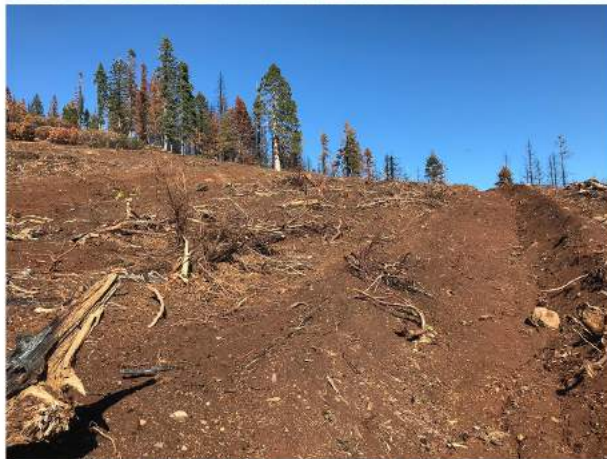
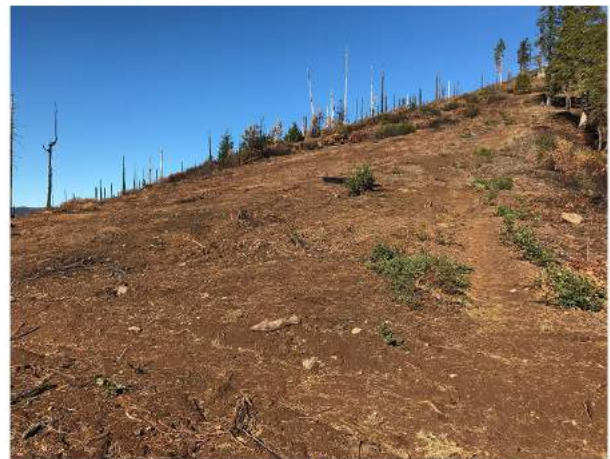
1(e)i and ii Fireline bulldozed over the Kelsey National Recreation Trail at Siskiyou Wilderness Area boundary, Eclipse Fire, California 2017. *Photo credit: Luke Ruediger/Klamath Forest Alliance.*

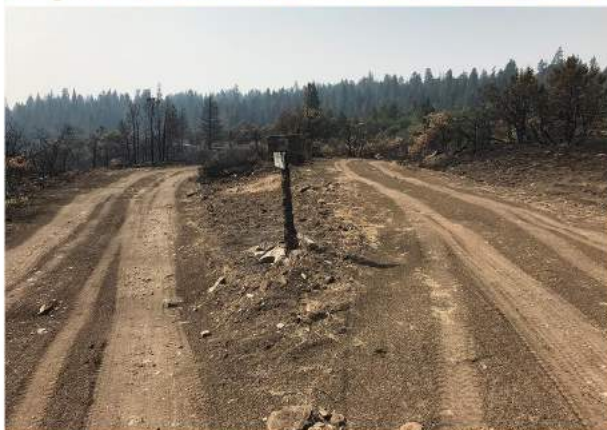
1(e)iii Fireline destroys Lone Pilot Trail, Soda Mountain Wilderness Klamathon Fire, Oregon 2018.
Photo credit: Luke Ruediger/Klamath Forest Alliance

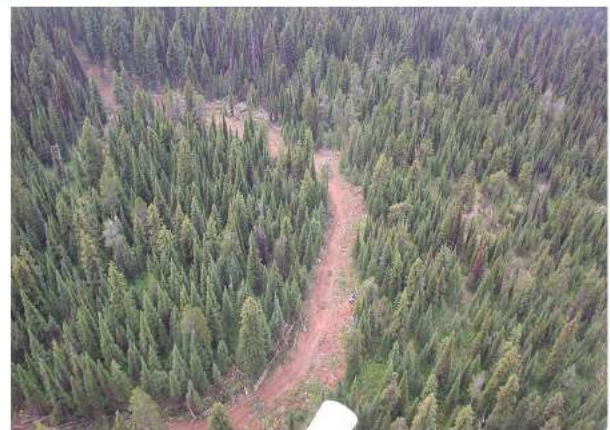
1(e)iv 1(e) Fireline miles from fire and built over a narrow trail. Picture and dozerline from 2003. Fireline was recut in 2015. Meadow Creek Roadless Area.
Photo credit: Friends of the Clearwater

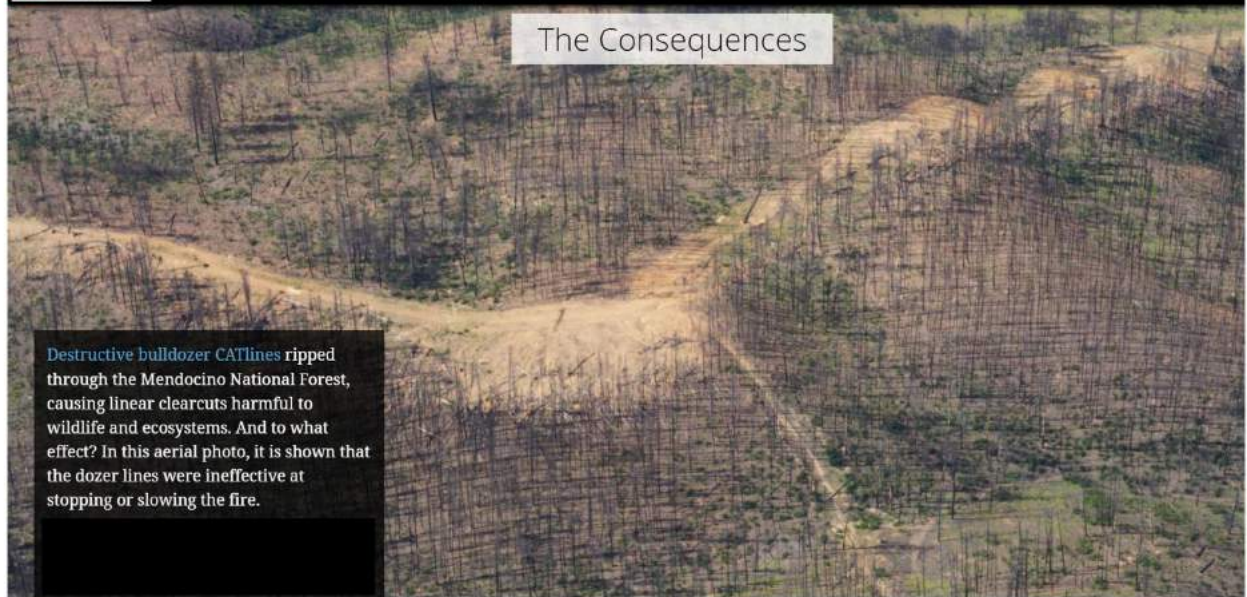
Destructive bulldozer CATlines ripped through the Mendocino National Forest, causing linear clearcuts harmful to wildlife and ecosystems. And to what effect? In this aerial photo, it is shown that the dozer lines were ineffective at stopping or slowing the fire.

2(b)i The Medocino Fire Complex burned over ineffective bulldozed firelines. The fire burned nearly 720 square miles (459,000 acres) and a firefighter was killed. Fire crews and agency personnel predicted that these firelines would have a low probability of success, but they bulldozed them under pressure to “do something”.

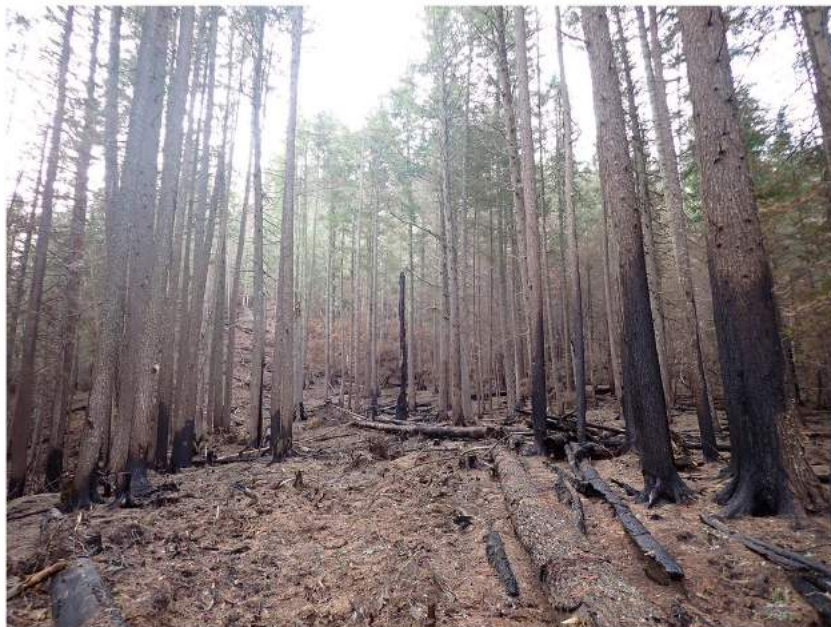
2(b)ii Forest Service cut a fireline up a steep incline above a creek, miles from any community. Fire burned over the fireline, Sand Mountain Fire, Idaho 2021.

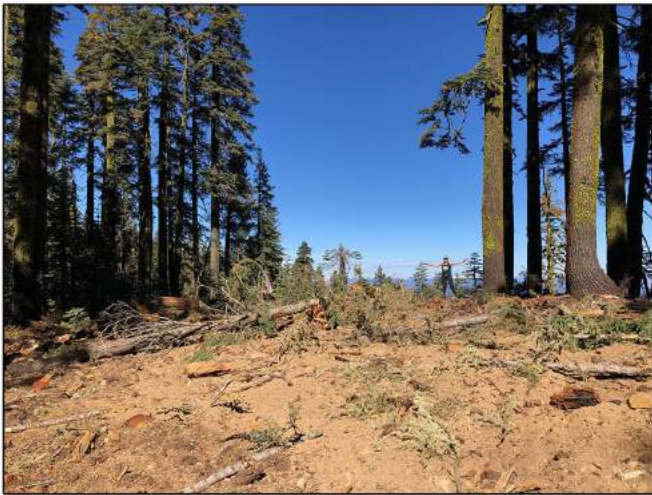
3(a)i Dixie Fire Suppression efforts cost 639 millions dollars. Many of the firelines did not see fire. This fireline is in the Bucks Lake Wilderness.

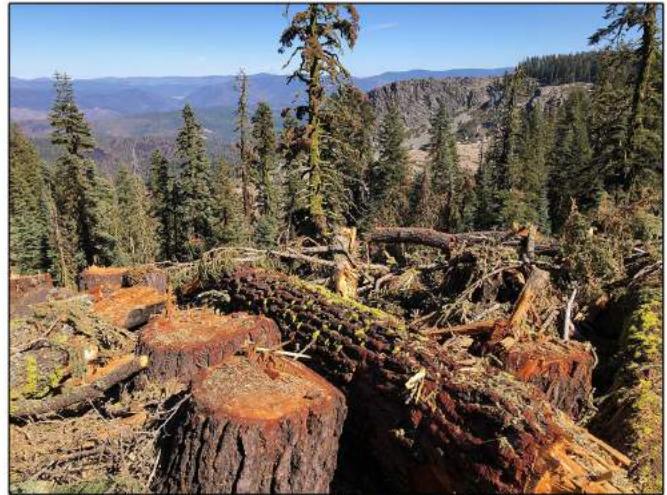
3(a)ii Fireline leaves stumps along the Pacific Crest Trail, Bucks Lake Wilderness Area during Dixie Fire, California 2021. The fireline did not see fire.

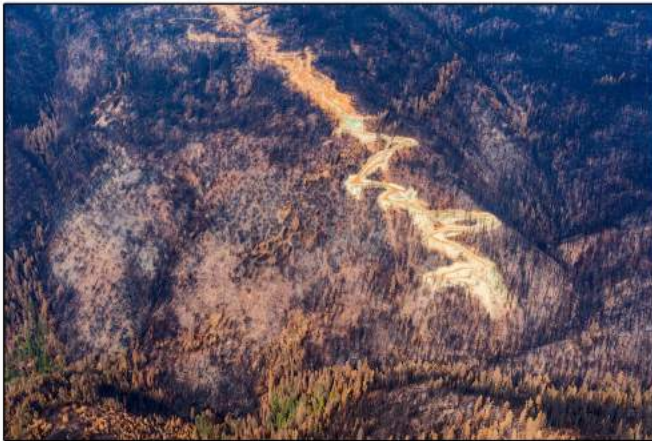
3(a)iii An ineffectual dozerline along a ridge. This will likely create a legacy sediment site above the creek, Dixie Fire, California 2021.

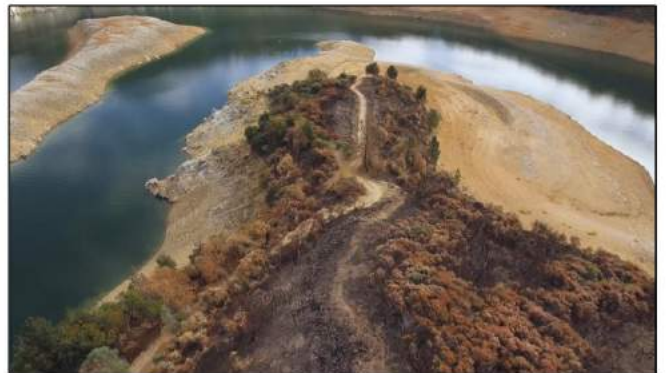
3(b)i Firelines were bulldozed right to the lakeshore and now dump sediment into the water. Photo was taken Fall of 2018 when lake level was low. Carr Fire, California 2018.

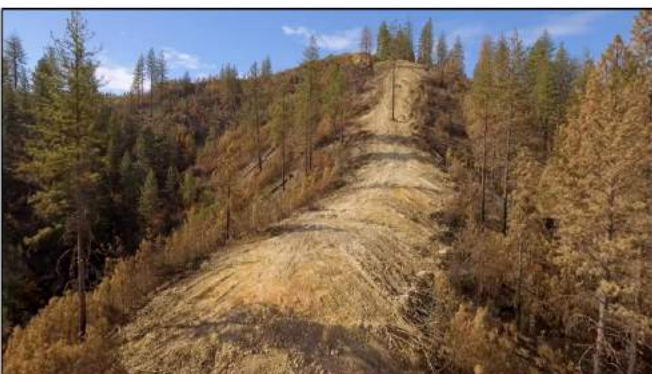
3(b)ii Firelines leave clearcut corridors that fragment and degrade wildlife habitat. This catline failed to stop the fire from crossing over the ridge, Carr Fire, California 2018.

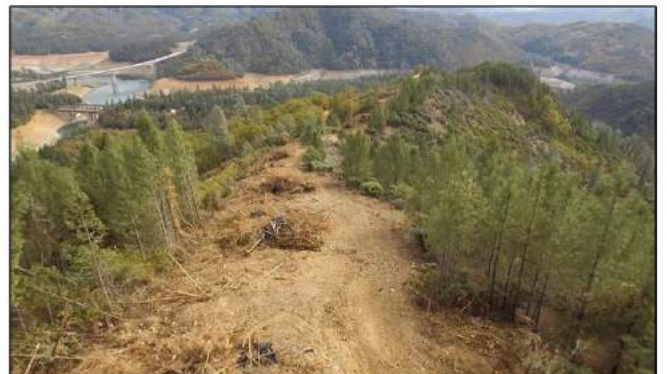
3(b)iii Fireline running along a ridgeline near Shasta Lake. It did not see fire, Carr Fire, California 2018.

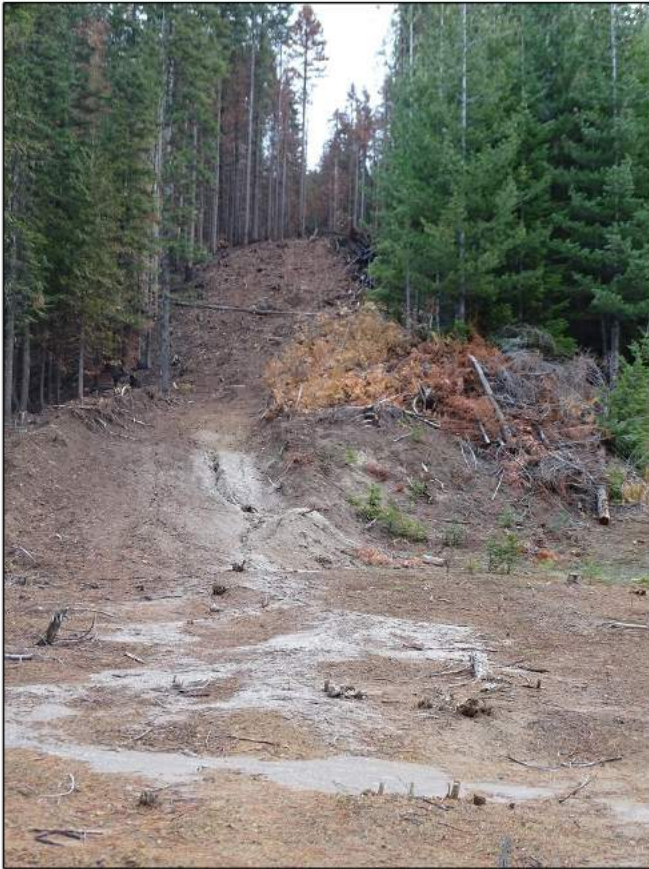
3(c)i Erosion from a steep dozerline Johnson Creek Fire, Idaho 2017. *Photo credit: Friends of the Clearwater*

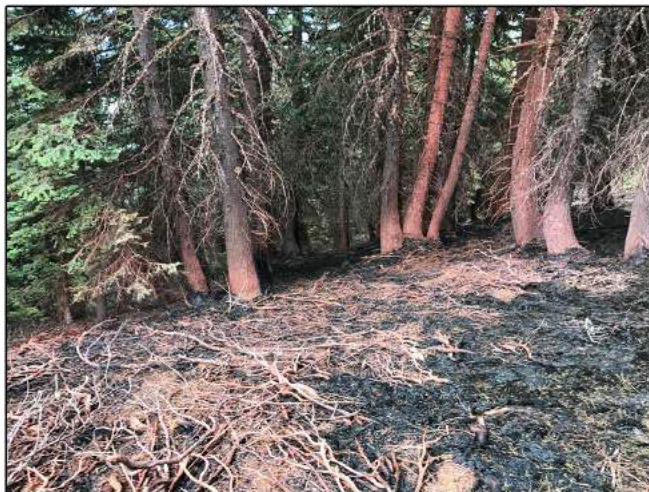
3(c)iv Fire retardant drop at edge of wet meadow in Kangaroo Inventoried Roadless Area, Credeence Fire, Oregon, 2017. Fire retardant is toxic to fish, amphibians and other wetland inhabiting species. Wetlands, rivers and streams are "avoidance areas," but are often impacted by misapplication. *Photo credit: Luke Ruediger/Klamath Forest Alliance*

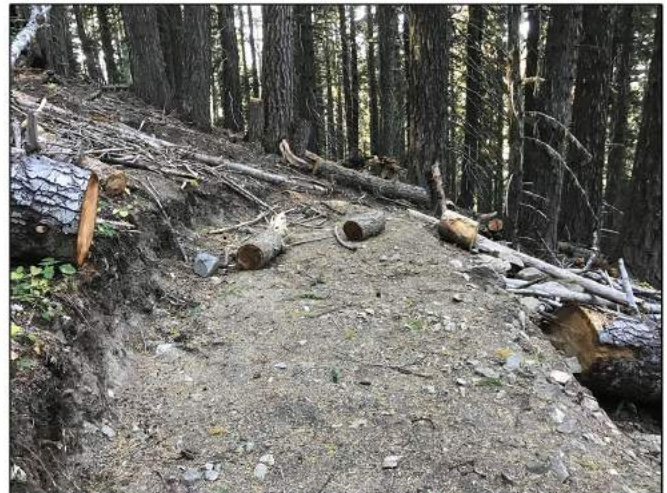
3(c)ii Unauthorized fireline built in the Kangaroo Inventoried Roadless Area which will bring in invasive fire prone weeds. Credeence Fire, Oregon 2017. *Photo credit: Luke Ruediger/Klamath Forest Alliance*

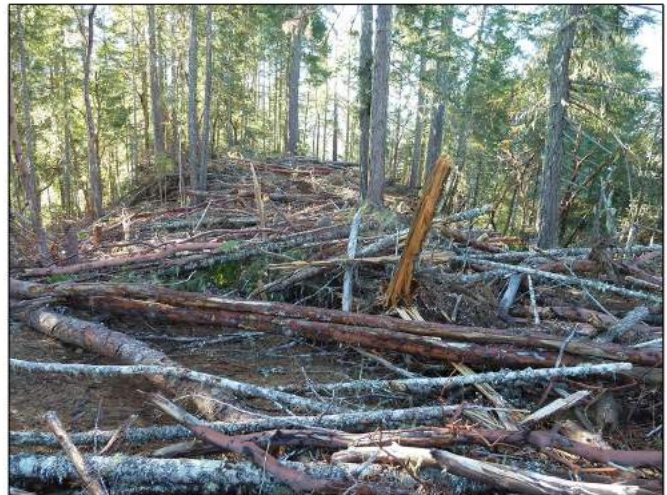
3(c)iii Dozerline following "rehabilitation" in Zane Grey Roadless Area, Big Windy Fire, Oregon 2013. *Photo credit: Luke Ruediger/Klamath Forest Alliance*

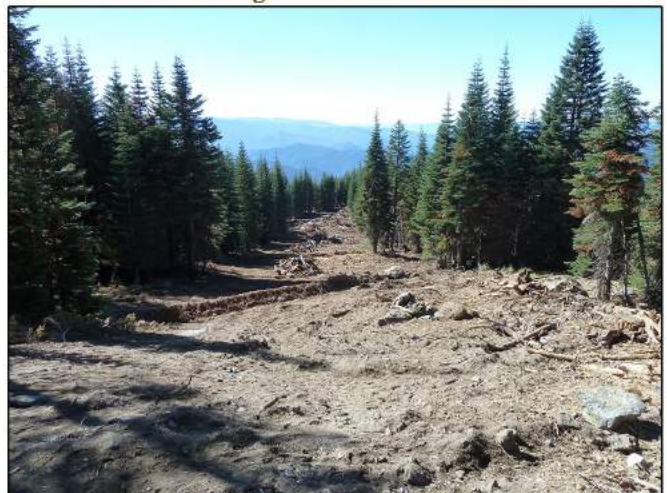
3(c)v Klamath National Forest dozerline Gap Fire, California 2016. *Photo credit: Luke Ruediger/Klamath Forest Alliance*

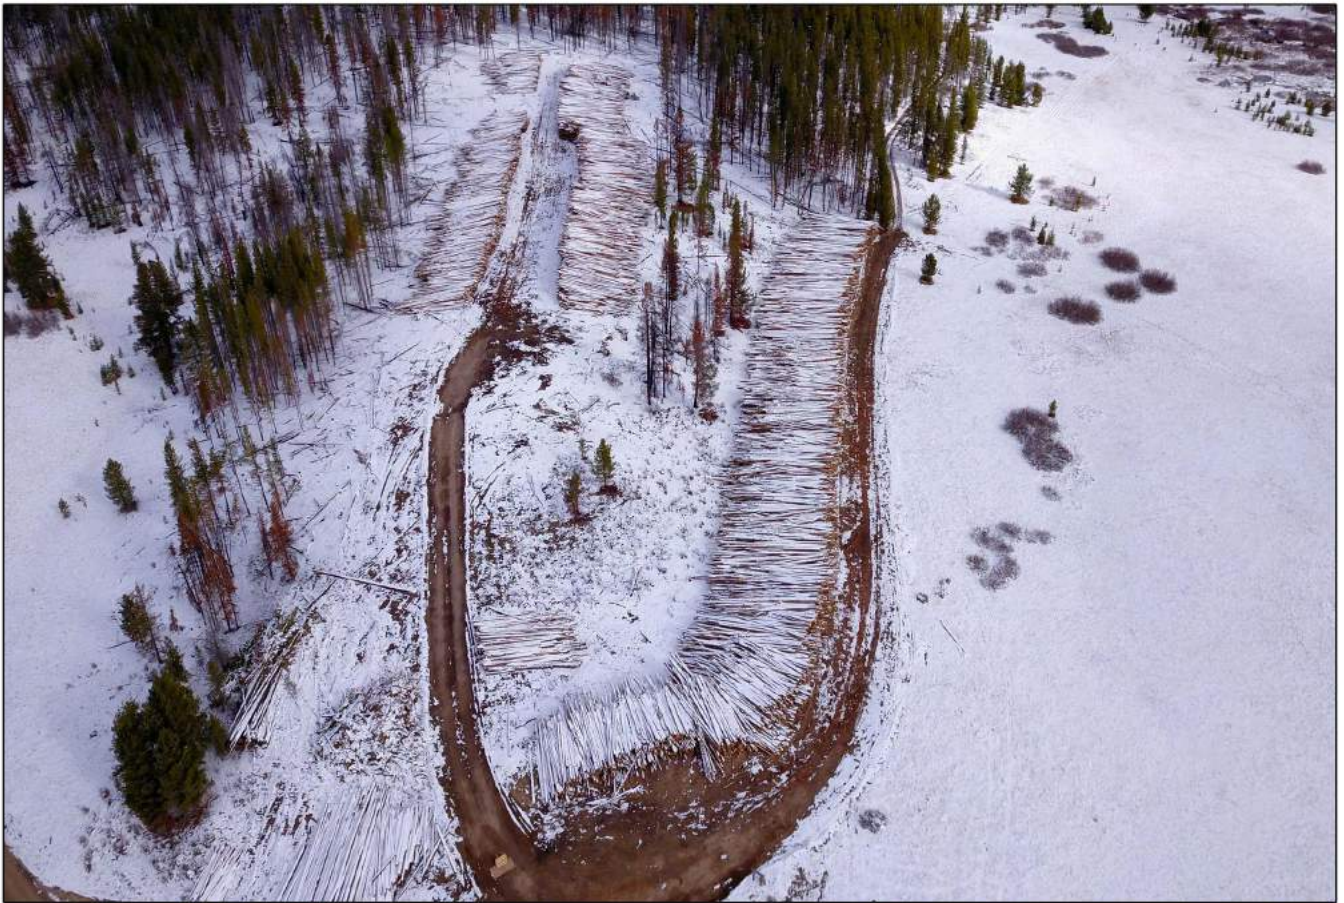
3(d)i Fireline slash left over from part of an 8 mile long linear clearcut, upwind, 1.5 miles from fire activity with wetlands in between, Trail Creek fire, Montana 2021.

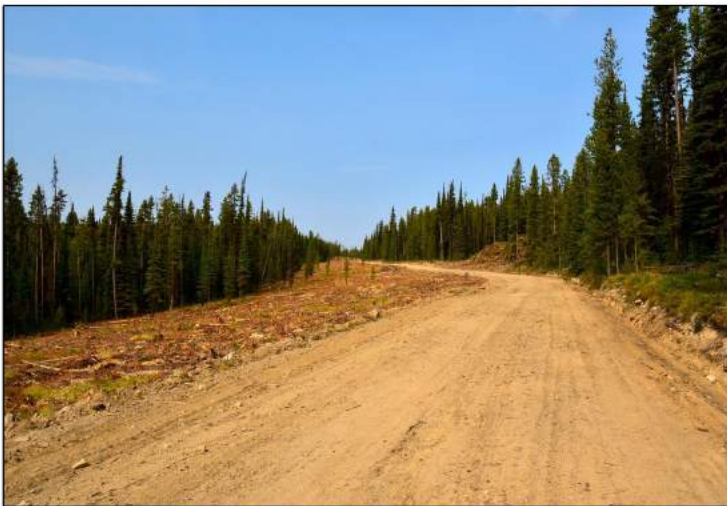
3(d)ii Forest Service allowed a private contractor to complete fire-line upwind from fire perimeter, even after the wildfire was no longer a threat to the area, Trail Creek Fire, Montana 2021.

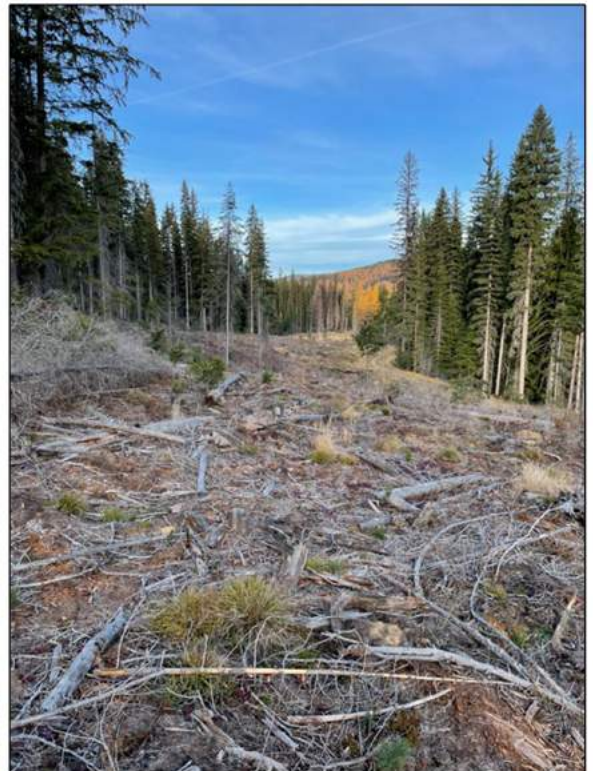
3(d)iii

Another unnecessary fireline from the Davis Fire, Montana 2018.
