Dead Laundry Monitoring Report

- Katie Bilodeau

Logging units and proposed road construction off of Forest System Road (FSR) 295

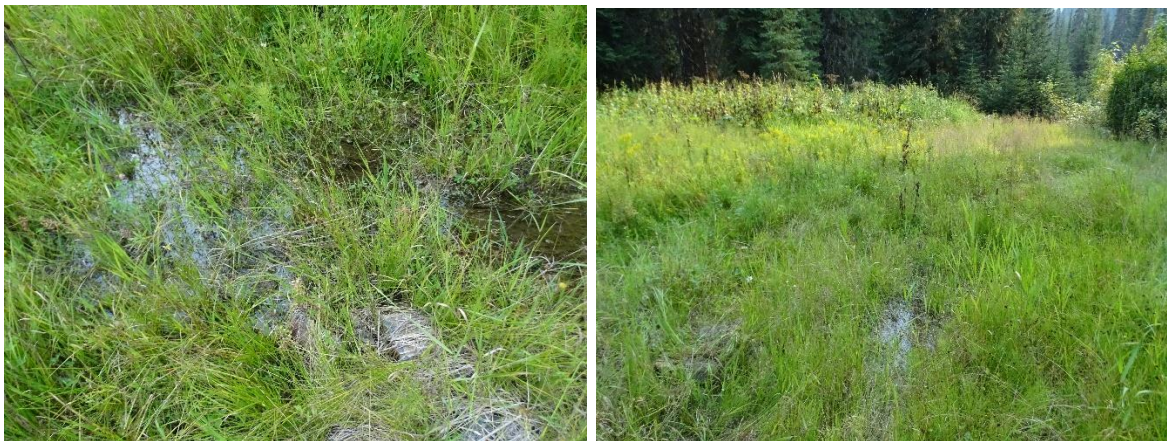
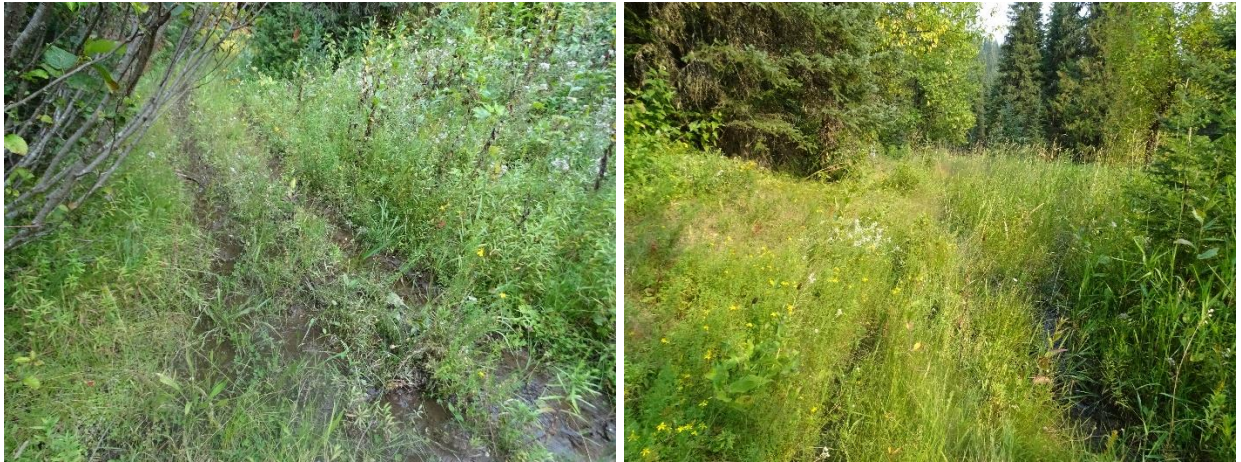
The pictures 4228 to 4250 were taken in the above area, where, according to the project proposal, the Forest Service will reconstruct some of the roads mapped above. Much of what we surveyed in these areas with roadbeds were essentially wetlands. They had soggy soils, vegetation that thrived in soggy soils, and even running water. Walking through this old roadbed, we stepped soil so saturated that it would sink down with our weight.

Above left, pic 4231; Above right, 4232; Below left, 4236 (water was running down the tire tracks); Below right, 4237 looking east overtop the area where Forest Service has inventoried

this in its road system (whether it be roadbed, road template, or stored road), as denoted by the GIS records FOC received from the agency in 2020.

Especially relevant is the season. We were here September 8, 2021—fall is not the time when things are wet unless water is present all year long.

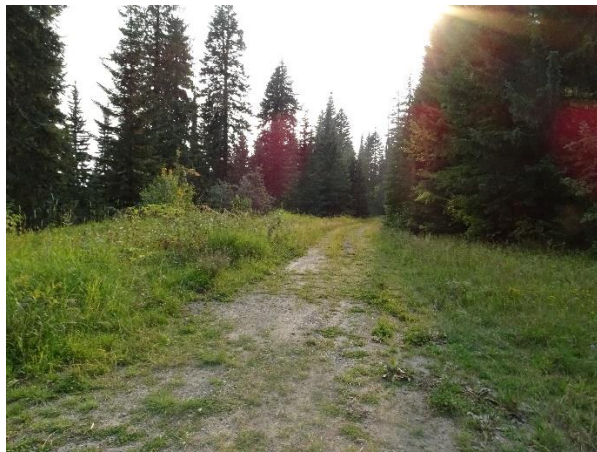
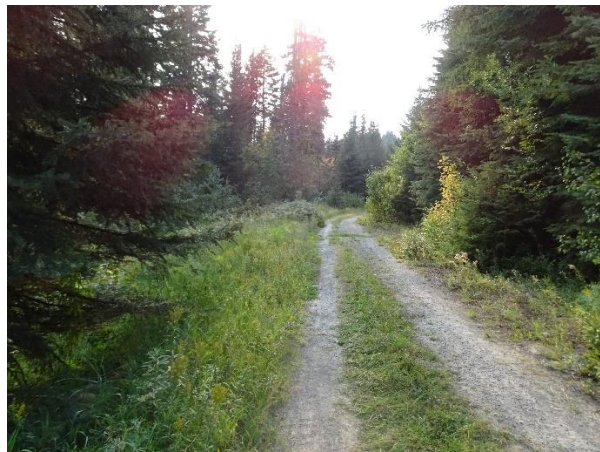
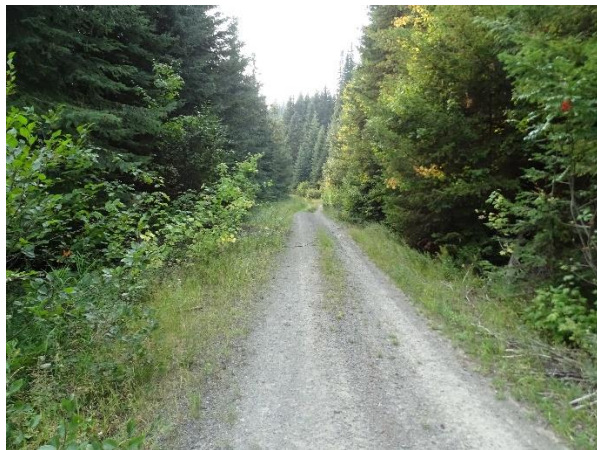
Above left, pic 4253; Above right, pic 4254; Below left, pic 4255; below right, pic 4256

As this road will have logging trucks on it, it is unclear as to whether this road will need to be widened.

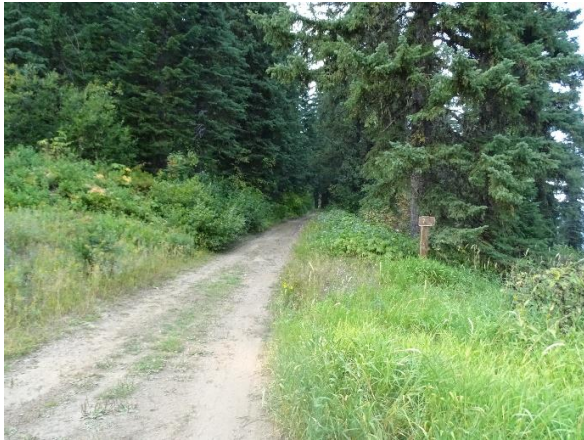
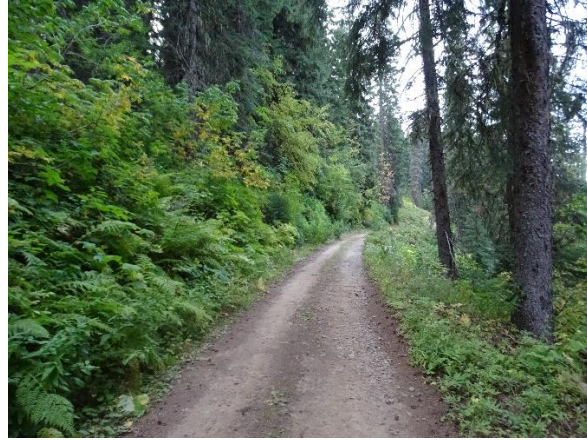
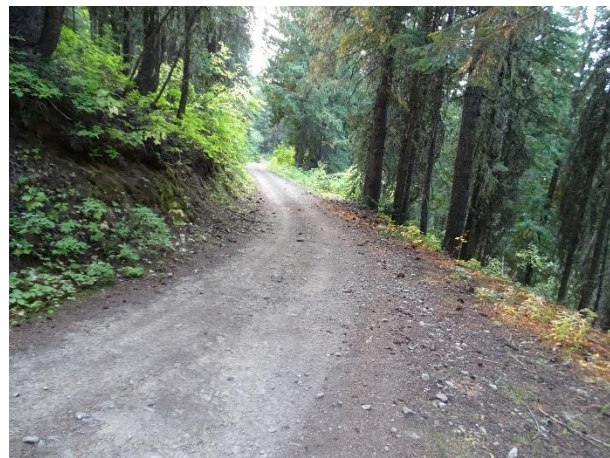
Above left, pic 4258; Above right, pic 4259; Below left, pic 4260; Below right, pic 4261.

According to the Forest Service's Dead Laundry Road Map, the agency has reconstruction planned for FSR 735. From the width of this road, and the hillside it is cut into, it is difficult to imagine how this roadwork could not include cutting further into the hillside and cutting trees to widen the road.

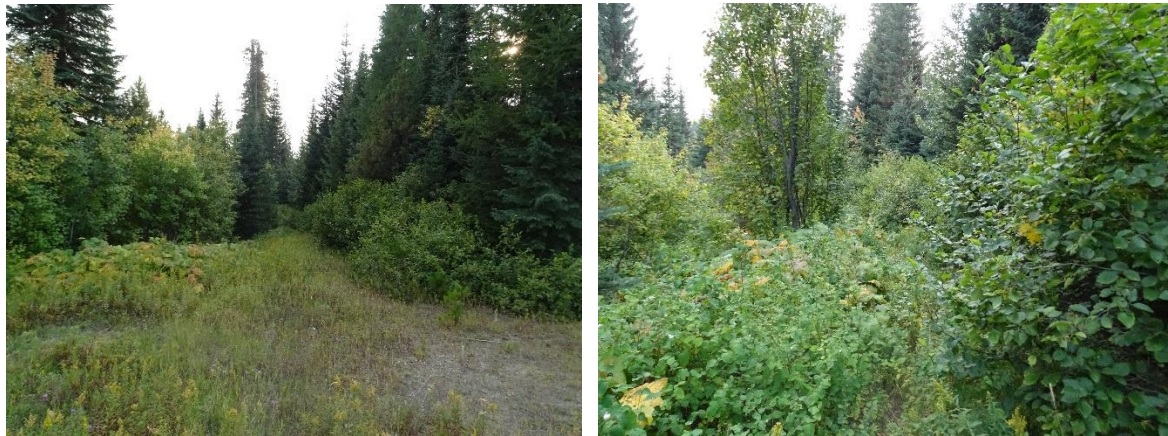
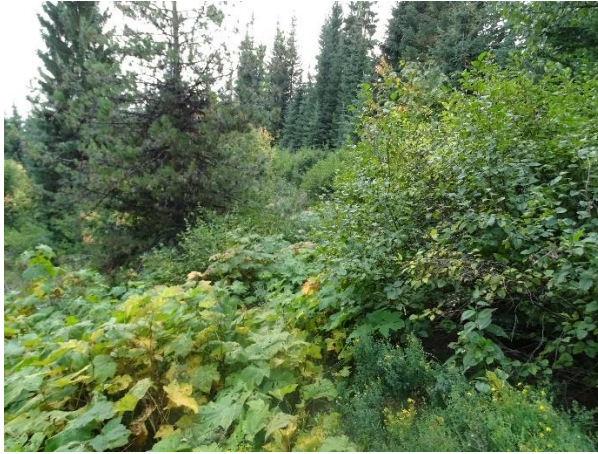
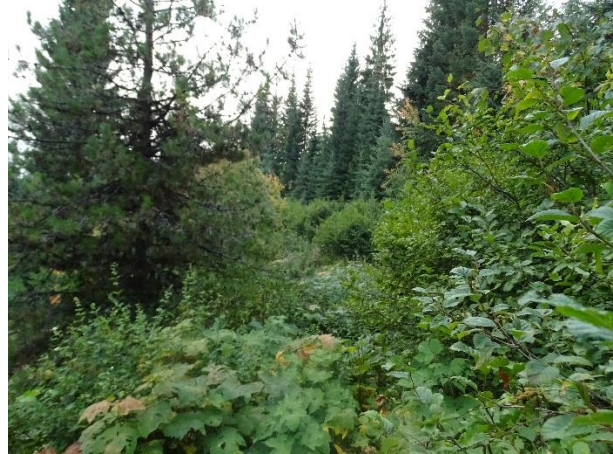
We first walked up FSR 737G. The below overgrown area was a hard “road” to find on the Forest Road System. The below pictures note what the Forest Service has planned as road reconstruction.

Upper left, pic 4263; Upper right 4264 (same road, picture taken after walking 20 yards up); Lower left, pic 4265 (same road, 25 yards up); Lower right, pic 4266 (30 yards up)

Road reconstruction here would be so significant as to amount to new road construction. These pictures would require a very different level of road work than the reconstruction for pic 4253-4256 (FSR 5437).

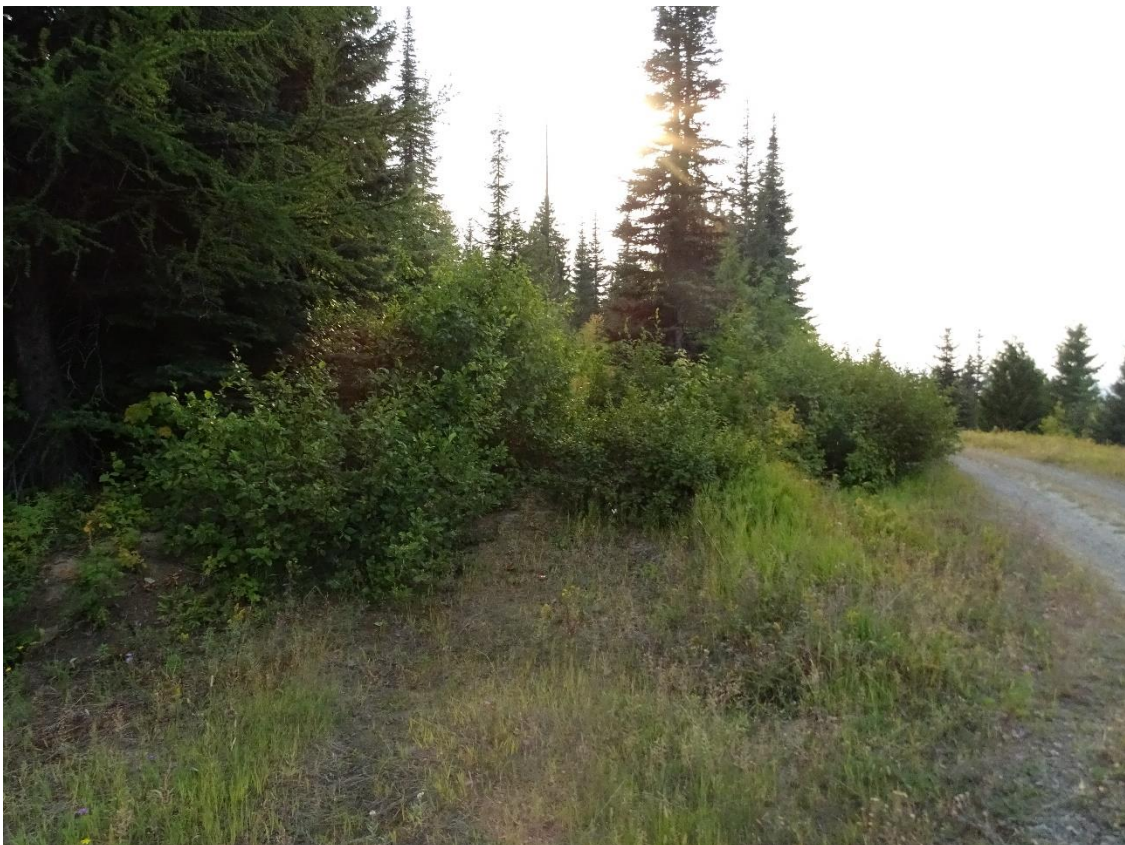
Next FOC staff walked up 737J. This road was not apparent from the main road FSR 737 (see pic 4268 below).

Above, pic 4268, start of FSR 737J.

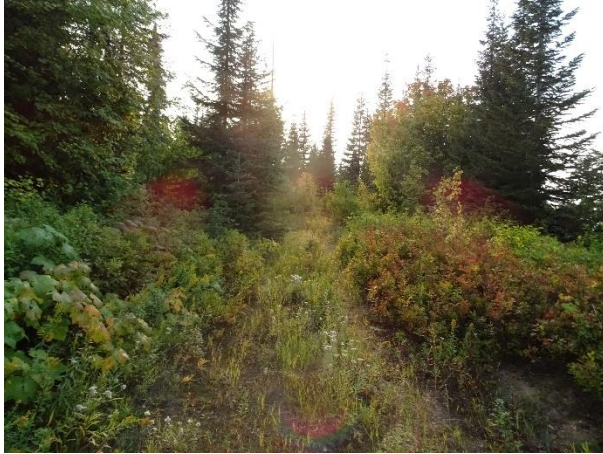
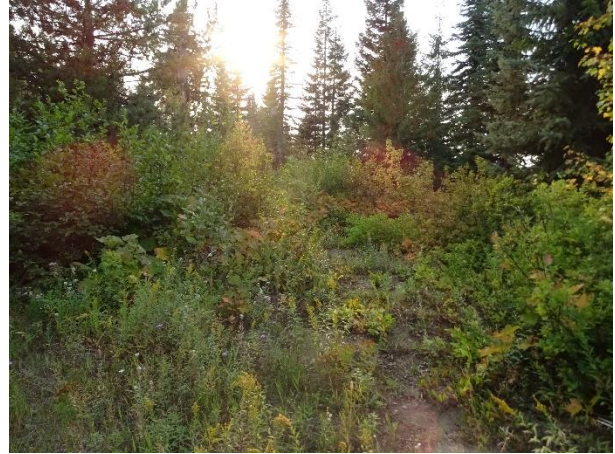
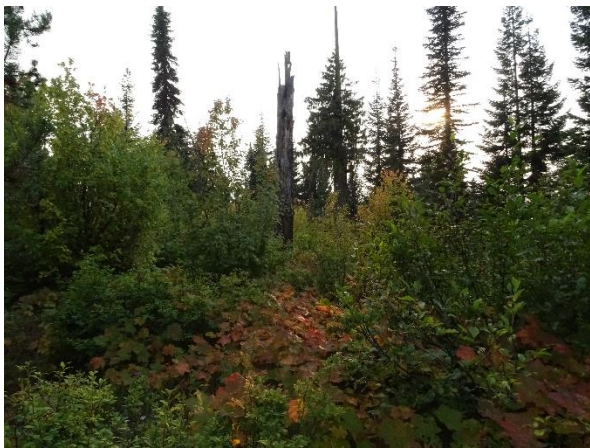
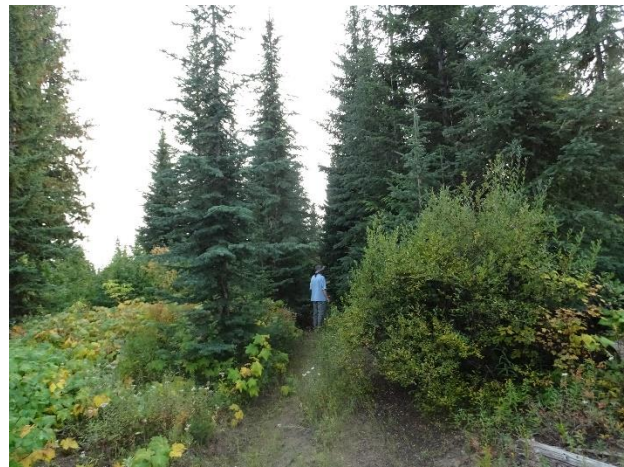
Upper left, pic 4269 (walking 10 yards up from pic 4268); Upper right, pic 4270 (20 yards up); Lower left, pic 4271 (30 yards up); Lower right 4275 (47 yards up).

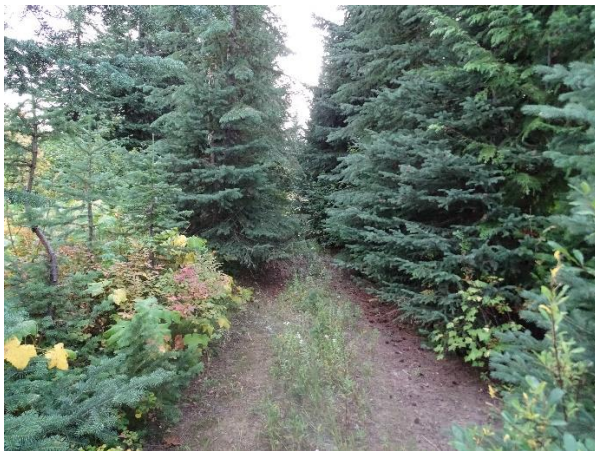
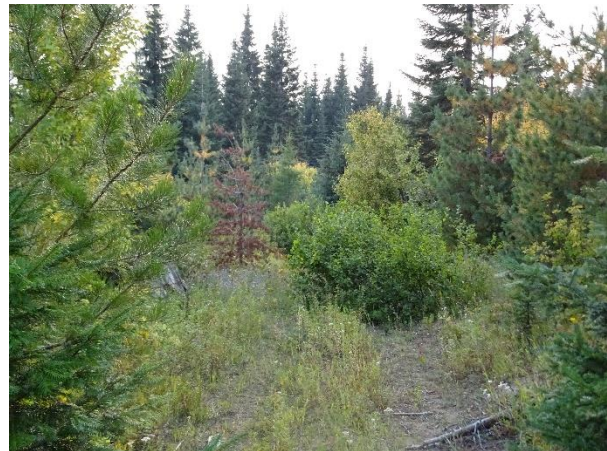
Below are two more pictures further up this “road.” Below left, pic 4277; Below right, pic 4281 (about where we turned around.)

The full suite of pictures is in the monitoring file, but this area is so recovered with vegetation that a road would essentially be new road construction.

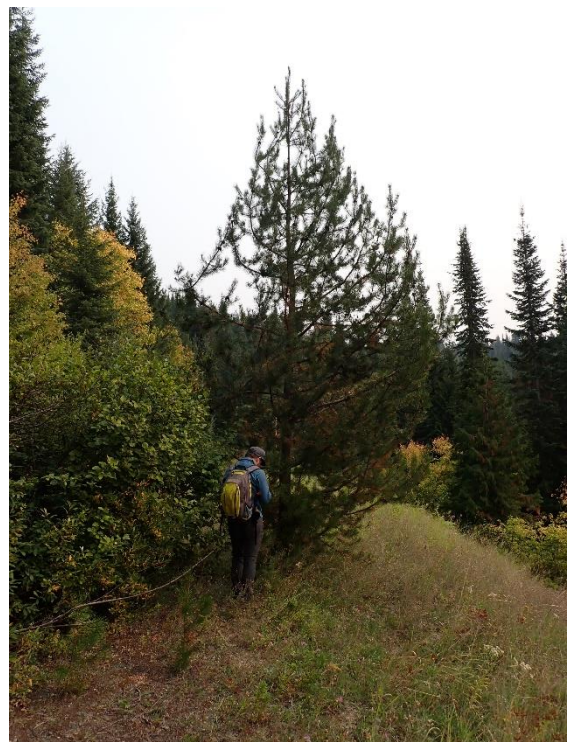
Given the level of recovery, this would also be significant road construction. See below.

Upper left, pic 22; Upper right, pic 27

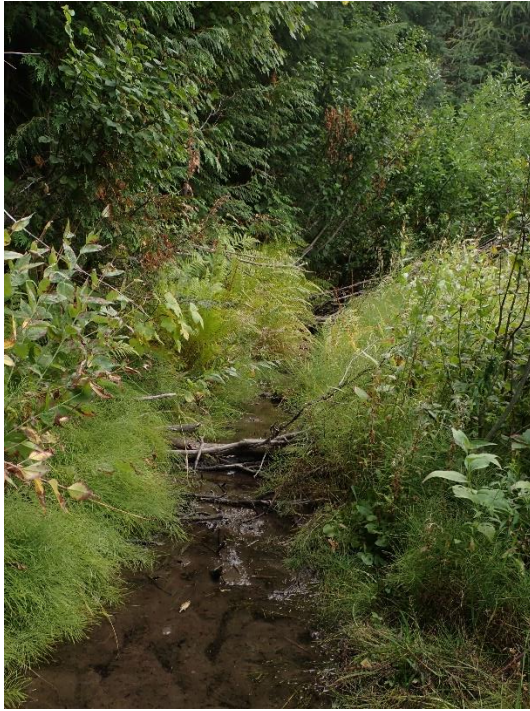
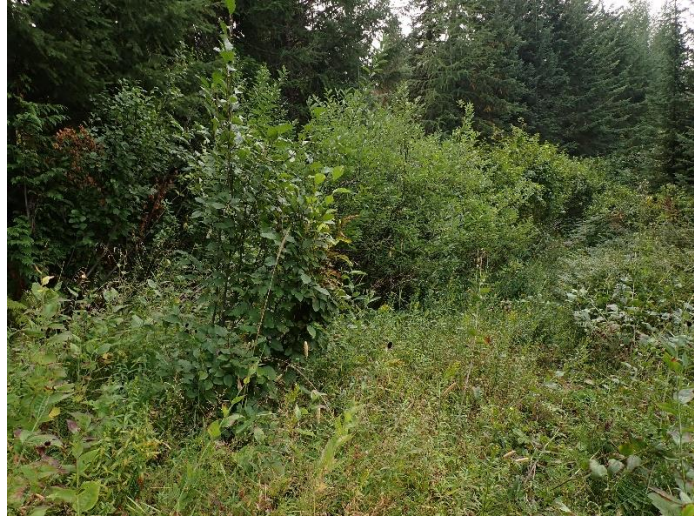
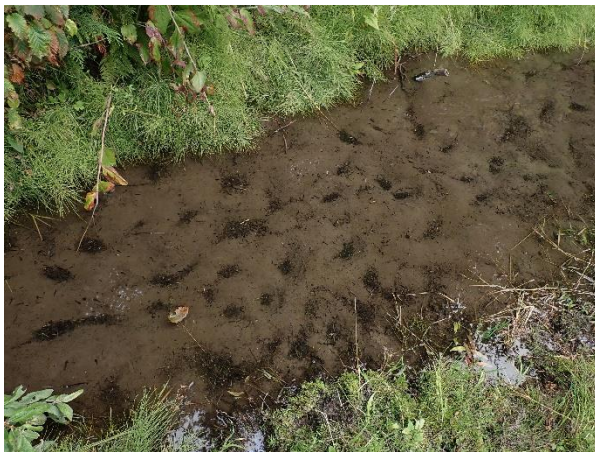
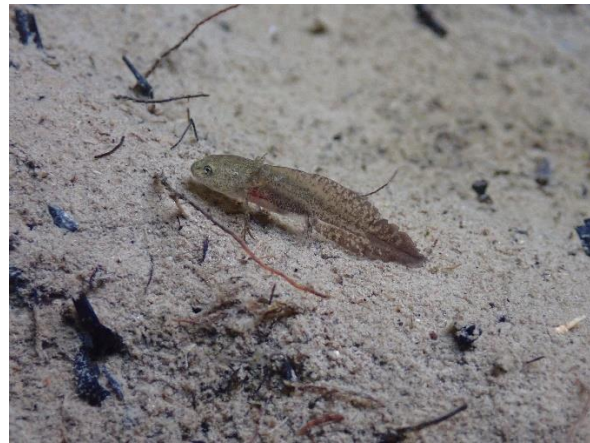
Notably, on FSR 5436, we located that the old roadbed is now a wetland system. The below pictures are an overview of the wetland that now exists on the old FSR 5436.

Above left, pic 65 (picture of roadbed that has become a wetland); Above right pic 66 (view to the right of pic 65). Below left, pic 63 (overshot of the wetland ecosystem in pic 65); Below right, pic 60 (salamander, aquatic wildlife in this wetland).

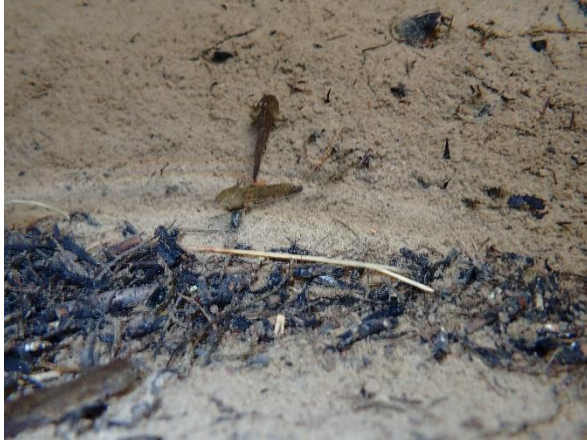
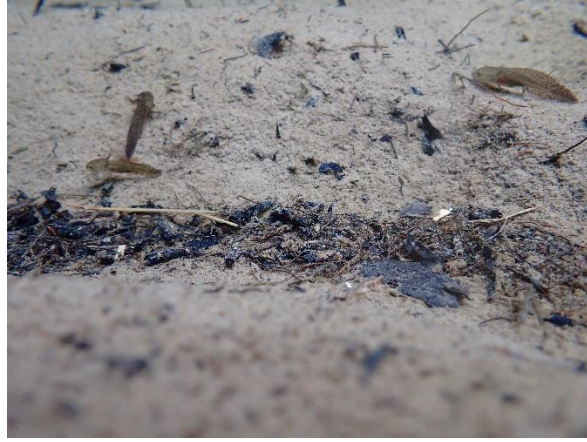
Below left, pic 55; Below right, pic 56 (FSR 5436)

This is on FSR 5436, and road construction will destroy the wetland that has evolved.

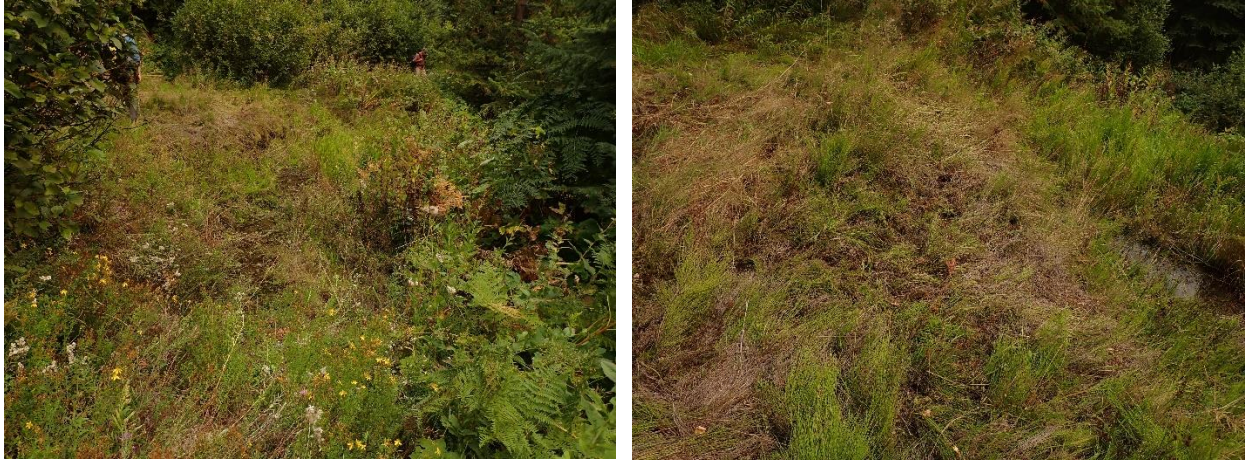
In this area, as noted in more detail, we found roads that were on older maps (i.e., the Osier Ridge Quadrangle) but not on the Forest Service's most recent road inventory. We also found roadbeds on hillsides sloughing and totally saturated. As demonstrated by the time stamps of the pictures, the below pictures were taken in the same area as pictures 98-102.

Upper left, pic 95; Upper right, pic 96

The pictures above were taken on a road that is not in the Forest Service’s most recent GIS inventory on roads that the agency disclosed to FOC in 2020. As seen in the above pictures, this non-road is a roadbed cut into a hillside. Also, in this particular are, this roadbed was totally saturated with water and seems to be sloughing away. Again, the timing of these pictures is the fall, when it is typically dryer than the spring.
